**THE EFFECT OF DISSOLVED OZONE ON THE CORROSION BEHAVIOR
OF MONEL 400, MONEL K-500, CDA 706, AND CDA 715 IN
SEAWATER**

J.H. Stevens and D.J. Duquette
Rensselaer Polytechnic Institute
Troy, New York 12180

October 1998

Report No. 5 to the Office of Naval Research
Contract No. N00014-94-1-0093

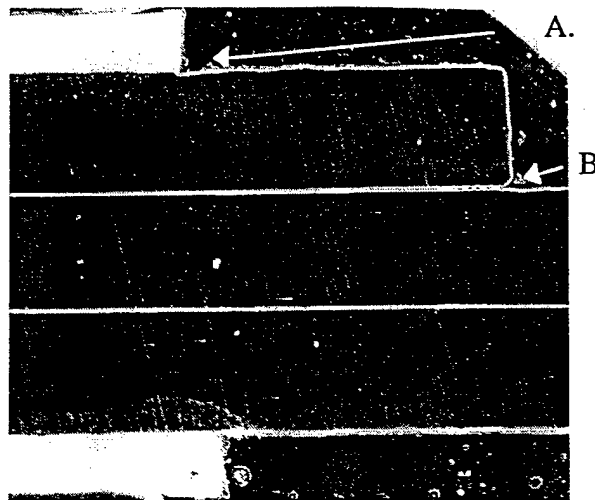
Figure 74 shows the attack typically seen on this alloy, and other alloys in this group. The small trench, at the mouth of both the metal-metal and metal-nonmetal

crevice, seen in this alloy is typical of the localized attack seen in this group of alloys. The white areas are the PTFE washers used to create the metal-nonmetal crevice and isolate the crevice assembly from the bolt and nut, preventing galvanic attack.

Figure 74. Cross section of C-22 crevice assembly exposed for sixty days to ozonated seawater. White areas are PTFE washers while the rest of the areas shown are C-22. A. and B. show attack at the mouths of the crevice. 14X
